2.2 NATURAL RESOURCES ASSESSMENT AND PROBLEM IDENTIFICATION

Stevenson Creek Watershed Management Plan Final Report

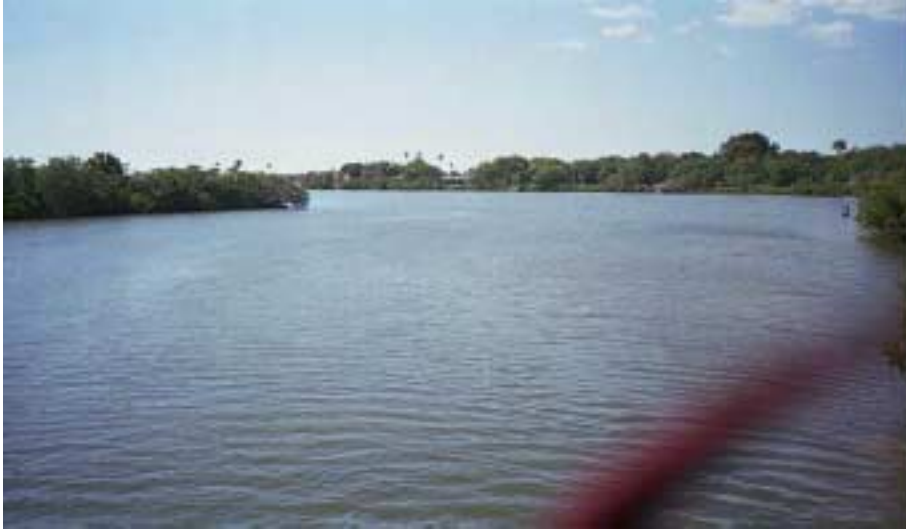
The photo to the left was taken on the north bank of Stevenson Creek west of the Douglas Avenue Bridge. The view is to the southeast

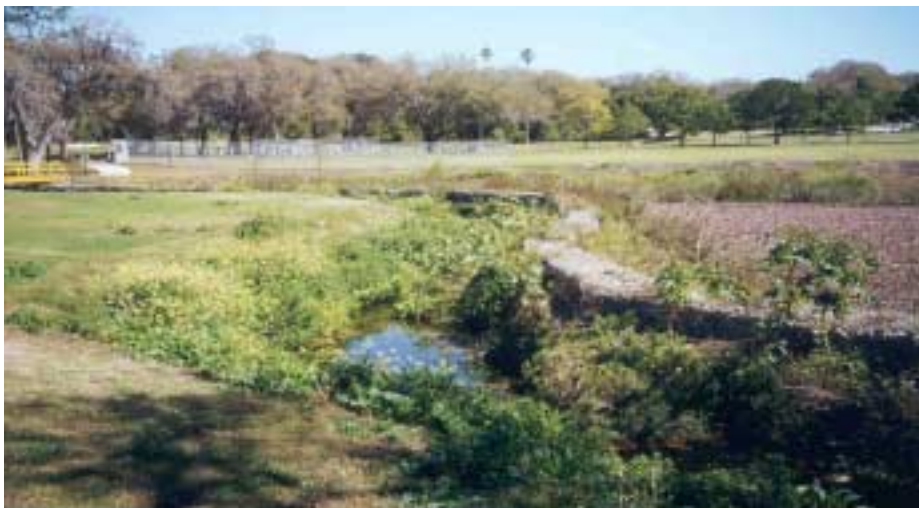
Stevenson Creek meanders through the Clearwater Country Club golf course on a semi-natural streambed. There have been previous attempts to create marsh habitat on-line with the creek that have been somewhat successful. On-line wetlands are always difficult to create because of the need to accommodate the occasional heavy volumes of water flowing through the stream and the potential for erosion. In addition, maintenance is difficult due to the nuisance exotic vegetation that can be washed in from problem areas upstream. In spite of the drawbacks, the golf course provides one of the best potential areas for habitat improvement, depending upon the available area.

This photo shows the mitigation area within the golf course. The low gabion wall was installed to protect the mitigation area from erosion and the influx of exotic vegetation.

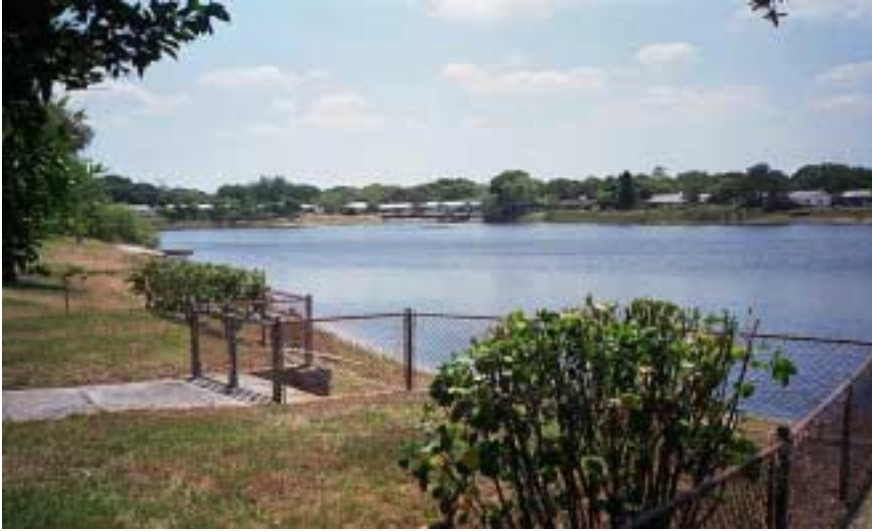
The photo to the left shows a view of Lake Hobart facing south. This lake is one of the larger water bodies.

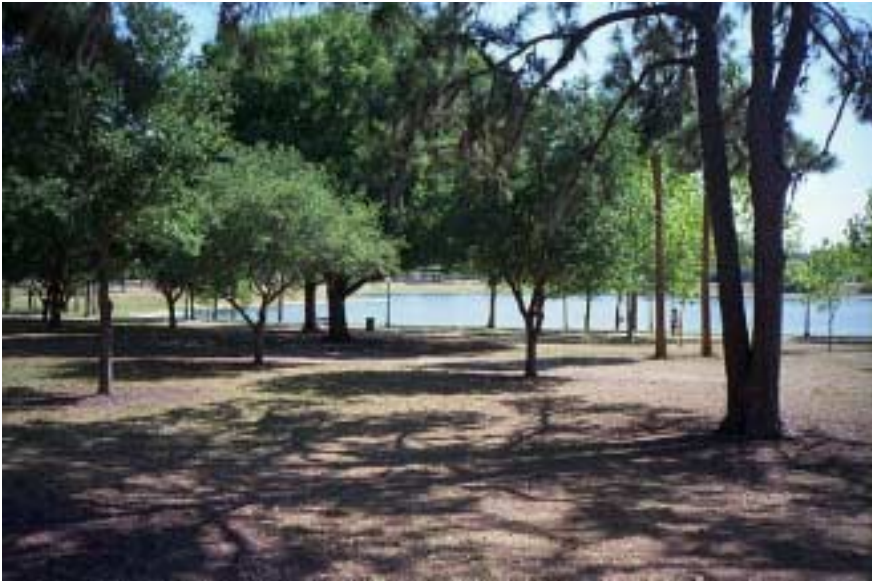
This photograph is a view of Crest Lake from the northeastern corner. The sparseness of the understory vegetation can contribute to erosion and sedimentation in the lake due to stormwater runoff.
