## **SECTION 2.0**

### **WATERSHED ASSESSMENT AND PROBLEM IDENTIFICATION**

***Stevenson Creek Watershed Management Plan  
Final Report***

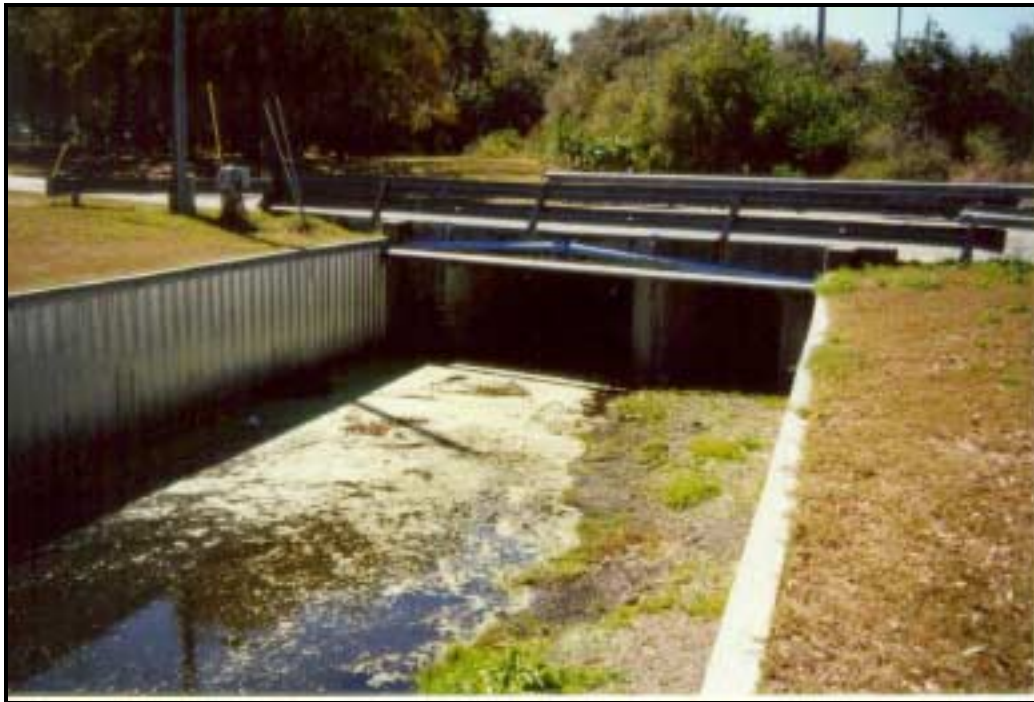
**Figure 2.1-7 Box Culverts Downstream of King's Highway Monitoring Station**

and flow conditions. No adjustments were made to the Manning's roughness in the vicinity of the Spring Branch at King's Highway station however, since within the range of the measurements, the flow appears to be controlled by the box culverts under King's Highway (refer to Figure 2.1-7). The simulated rating curve at this location provided a reasonable fit to the measured data without any adjustment to the Mannings "n" values.

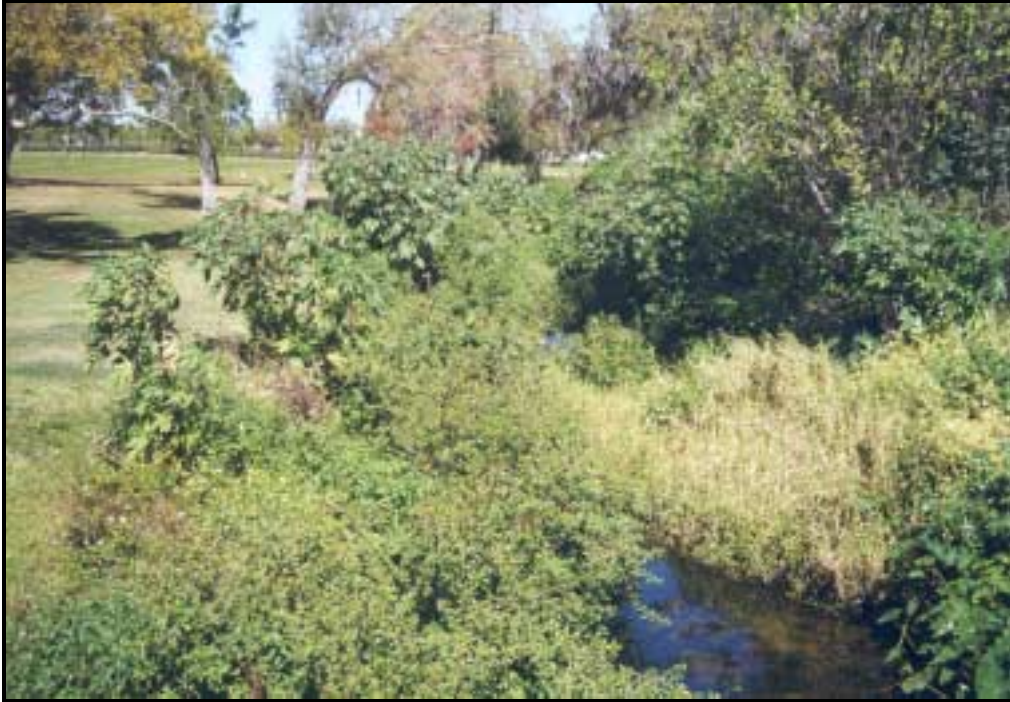
**Figure 2.1-8 Vegetation in Channel Downstream of Drew Street Monitoring Station**

At the Drew Street gage in Stevenson Creek, it was necessary to increase the in-bank Mannings "n" from the initial estimate of 0.07, to 0.09 for the cross section immediately downstream of the gage in order to match the measured data. In a field visit in March of 2000, this section was observed to be heavily vegetated (refer to Figure 2.1-8), although the degree of vegetation in the channel generally decreased in the sections further downstream through the golf course. Of course, the degree of vegetation varies not only with location, but also with time of year and point in the maintenance cycle.

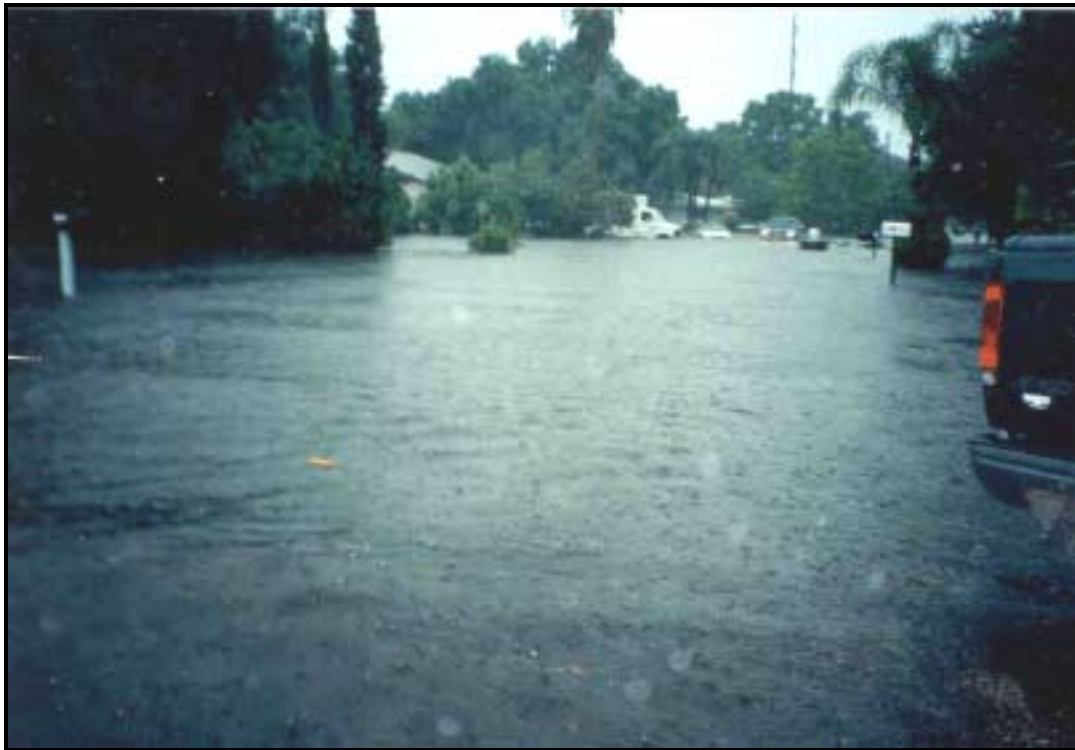
**Figure 2.1-25 Flooding on Hillcrest Avenue, South of Lakeview Road  
Storm of July 15 , 2000**

Upper Stevenson Creek encompasses the portion of the Creek targeted for conveyance improvements in Phase 3 of the 1988 W.K. Daugherty study. This phase was never constructed, primarily due to environmental concerns over the proposed improvement method of hardlining (paving) the channel with concrete. In the current analysis, the Upper Stevenson Creek subwatershed was found to contain 85 structure FPLOS deficiencies. All of these lie within the floodplain of the main channel of Stevenson Creek, with the largest concentration of them occurring on both sides of the Creek between Jeffords Street and Lakeview Avenue, and along Hillcrest Avenue south of Lakeview Road (see Figure 2.1-25).
